ASSESSMENT OF RENOVATIONS

**Bridgewater Elementary School
500 South Street
Bridgewater, Massachusetts
August 2003**

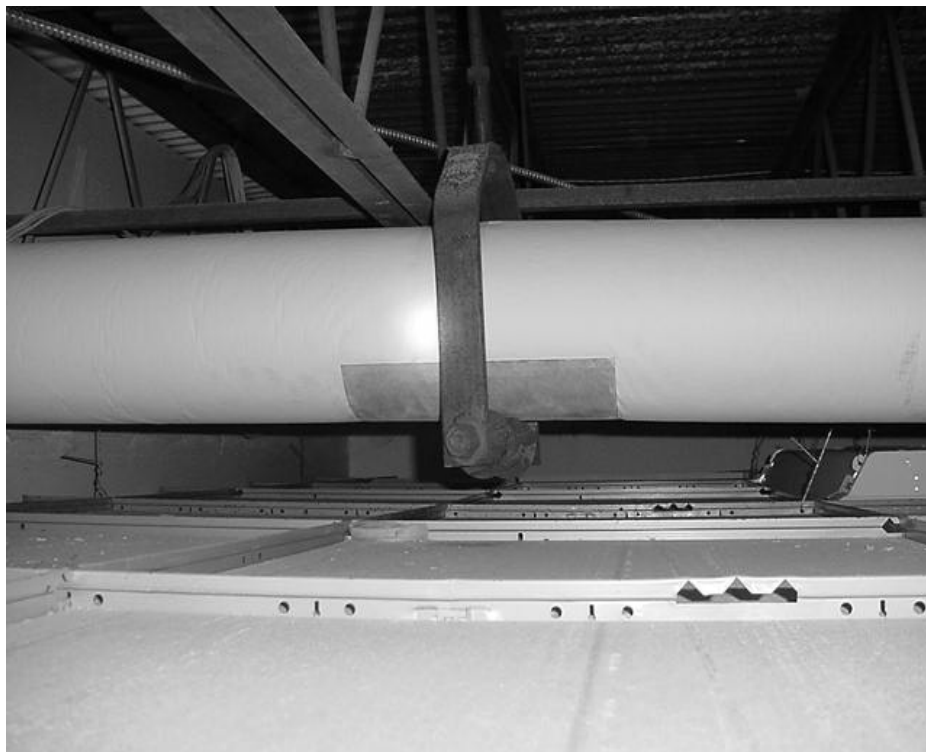
Picture A-1

Example of New Pipe Insulation in Ceiling Plenum above First Floor Classrooms

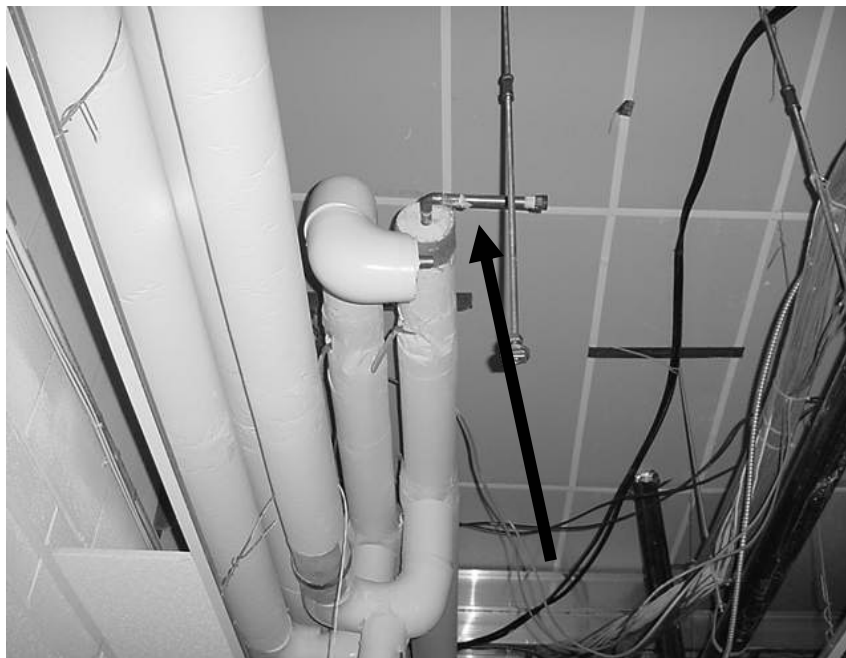
Picture A-2

Disconnected Chilled Water Pipes

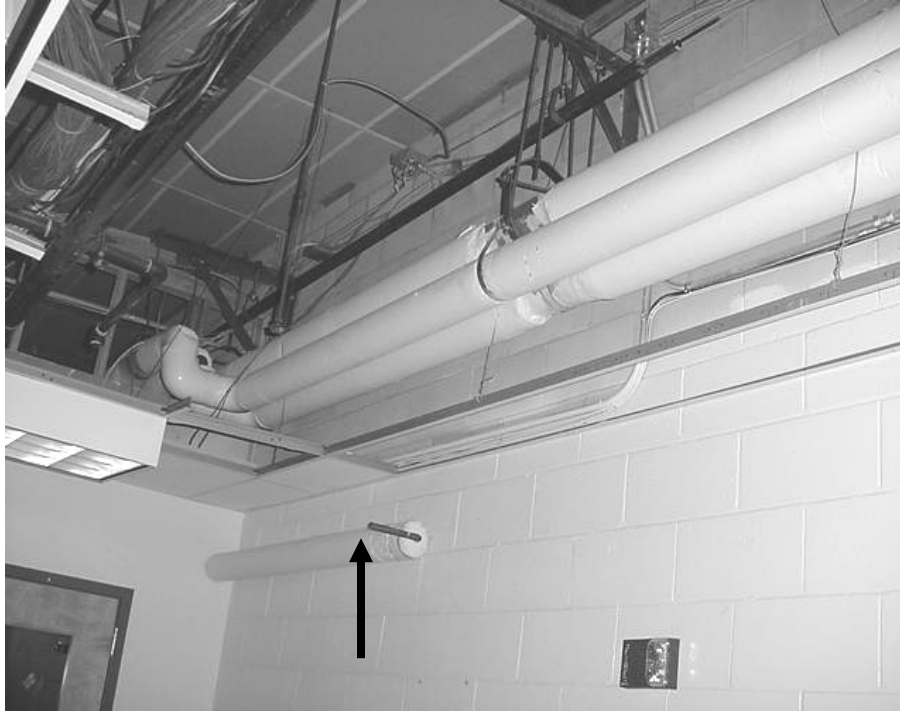
Picture A-3

Disconnected Drain Pan Drainpipes

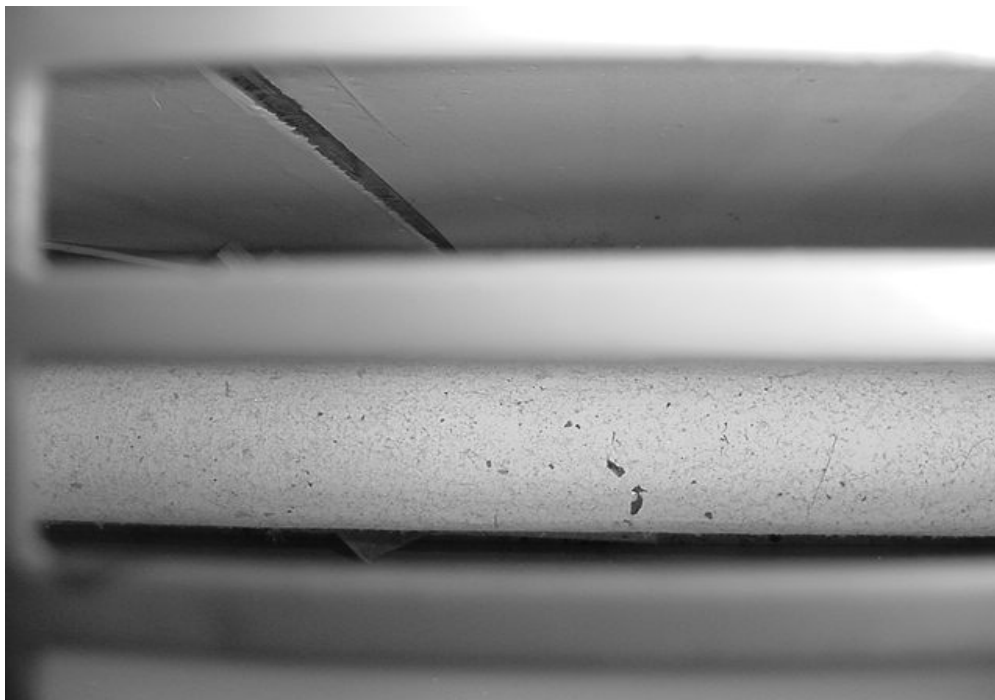
Picture A-4

Mold colonized pipe wrap was identified during the initial assessment. The wrap had not been removed from pipes in three rooms on the top floor (Picture 6). This pipe wrap extends behind a bookcase that was attached to wall mounted radiators. BEHA staff

Pipe Insulation in Southwestern Most Classroom at the Front of the BES

recommended that this insulation be removed, and accumulated materials should be removed from the radiator fins.

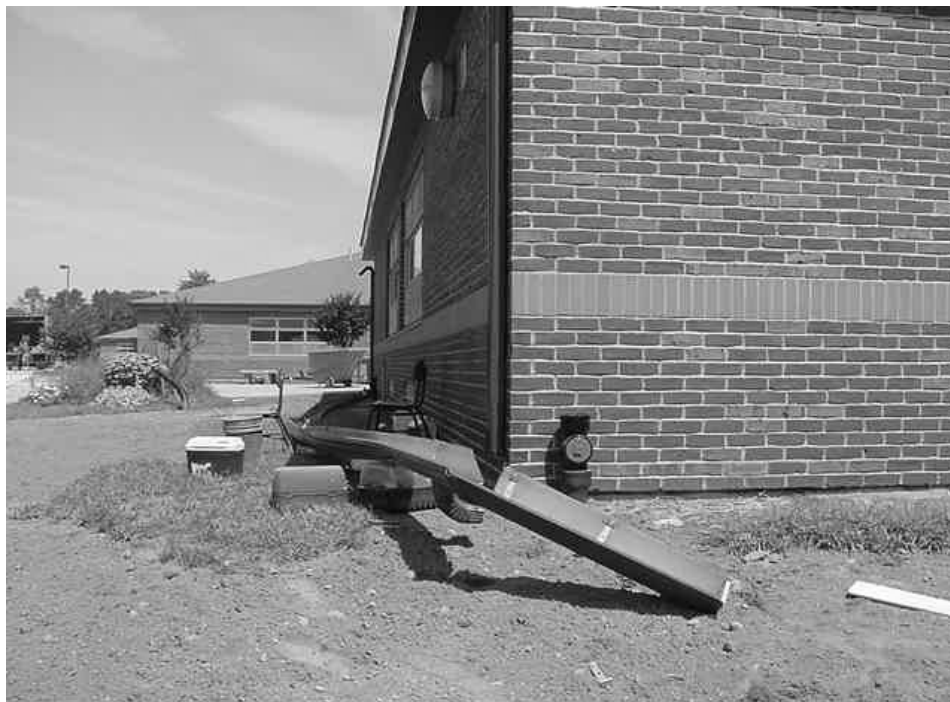
Picture A-5

Gutter/Downspouts Laid Out For Installation on Roof Edge

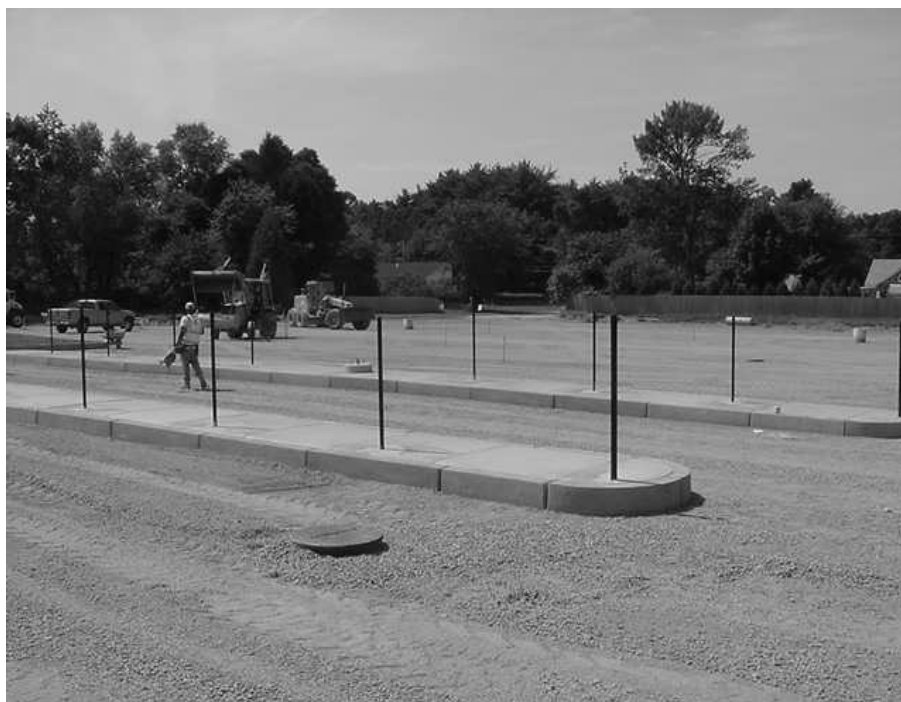
Picture A-6

Re-grading Of the Parking Lot In The Front Of the BES

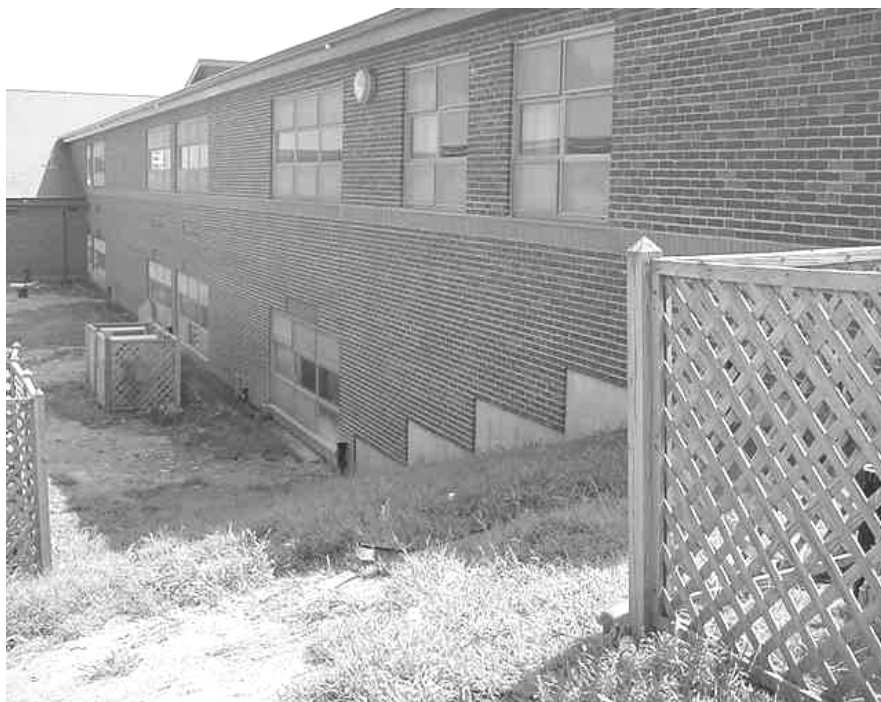
Picture A-7

Example of a Sloping Courtyard at the BES

2. Contour the slopes in the courtyard to direct rainwater away from exterior walls (Picture 9).
